Manhole Inspection Summary

Manhole # S47K__048MH

Record Plat: **47K** Node: **048** Status: **New Manhole (Not in GIS)** Insp Date: **7/28/08 12:00 AM**

Location Address: **2323-1 Patterson park ave** Cross Street: **unknown street**

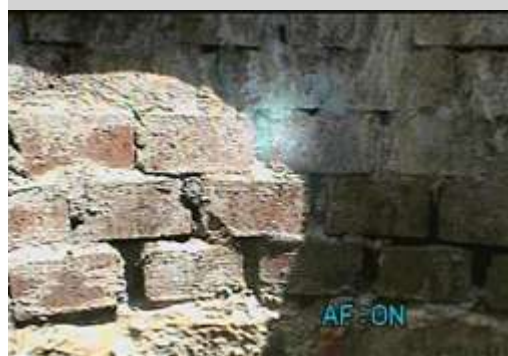
Defect 1

Chimney / Frame Adjustment ☒ Exists Material: **Brick** ☐ Parged Height: **16** (in.)
Condition: ☐ Sound ☐ Cracked ☐ Root Intrusion ☐ Loose Brick ☒ **Deteriorated**
Infiltration: ☒ None ☐ Joint ☐ Cracks ☐ Mortar ☐ Roots ☐ Wall

chimney -deteriorated frame adj

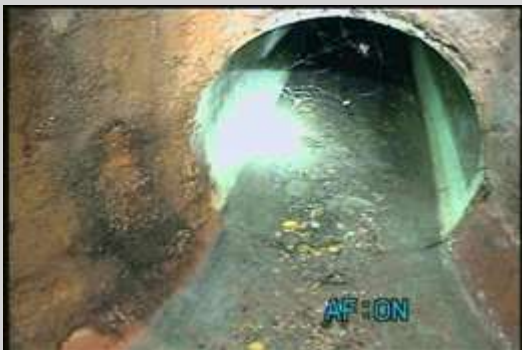
12 O'Clock Outflow

8 in. Circular Gravity Sewer
Pipe Out @ 12 O'Clock

Pipe Material: PVC ☐ Pipe Lined

Invert Depth: 8.00 (ft.) Flow Characteristics: Slow

Infiltration: None

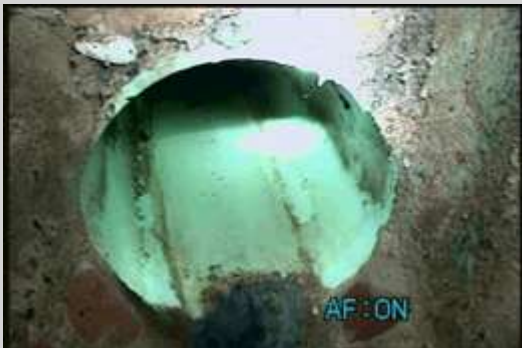
3 O'Clock Inflow

8 in. Circular Gravity Sewer
Pipe In @ 3 O'Clock

Pipe Material: PVC ☐ Pipe Lined

Invert Depth: 7.11 (ft.) Flow Characteristics: Slow

Infiltration: None

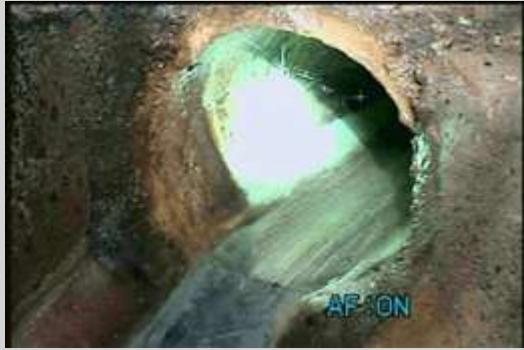
9 O'Clock Inflow

8 in. Circular Gravity Sewer

Pipe In @ 9 O'Clock

Pipe Material: **PVC** ☐ Pipe Lined

Invert Depth: **7.11** (ft.) Flow Characteristics: **Slow**

Infiltration: **None** Pipe Seal Cond: **Unknown**
